**TECHNICAL
SAFETY BC**

INVESTIGATION REPORT

FAILURE OF GAS FURNACES
WITH POLYPROPYLENE LINED
CONDENSING HEAT EXCHANGERS

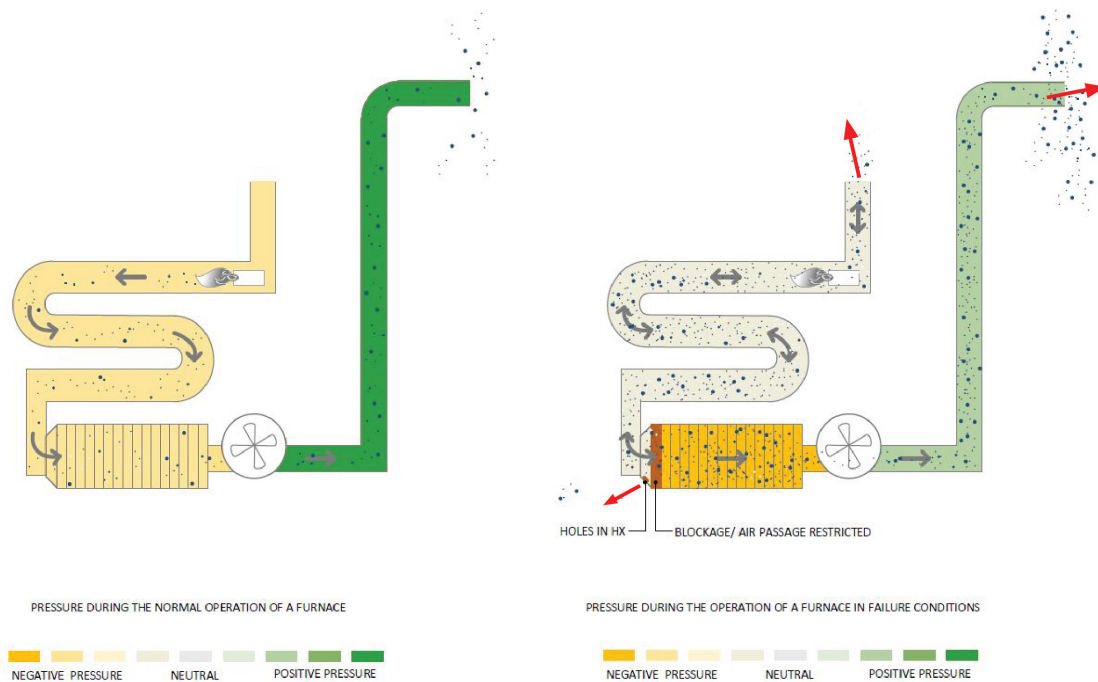
In a properly functioning gas furnace the products of combustion, including CO, are exhausted safely outdoors through the flue gas vent, as shown on the left of Figure 3. The engineering assessment found that in failed furnaces CO could enter the home via burner box opening and through openings at the secondary heat exchanger, caused by severe corrosion, as illustrated on the right of Figure 3.

Figure 3: Internal pressures, gas flow and CO produced in normal (left) and failed (right) condition (red arrows show paths for CO escaping furnace).

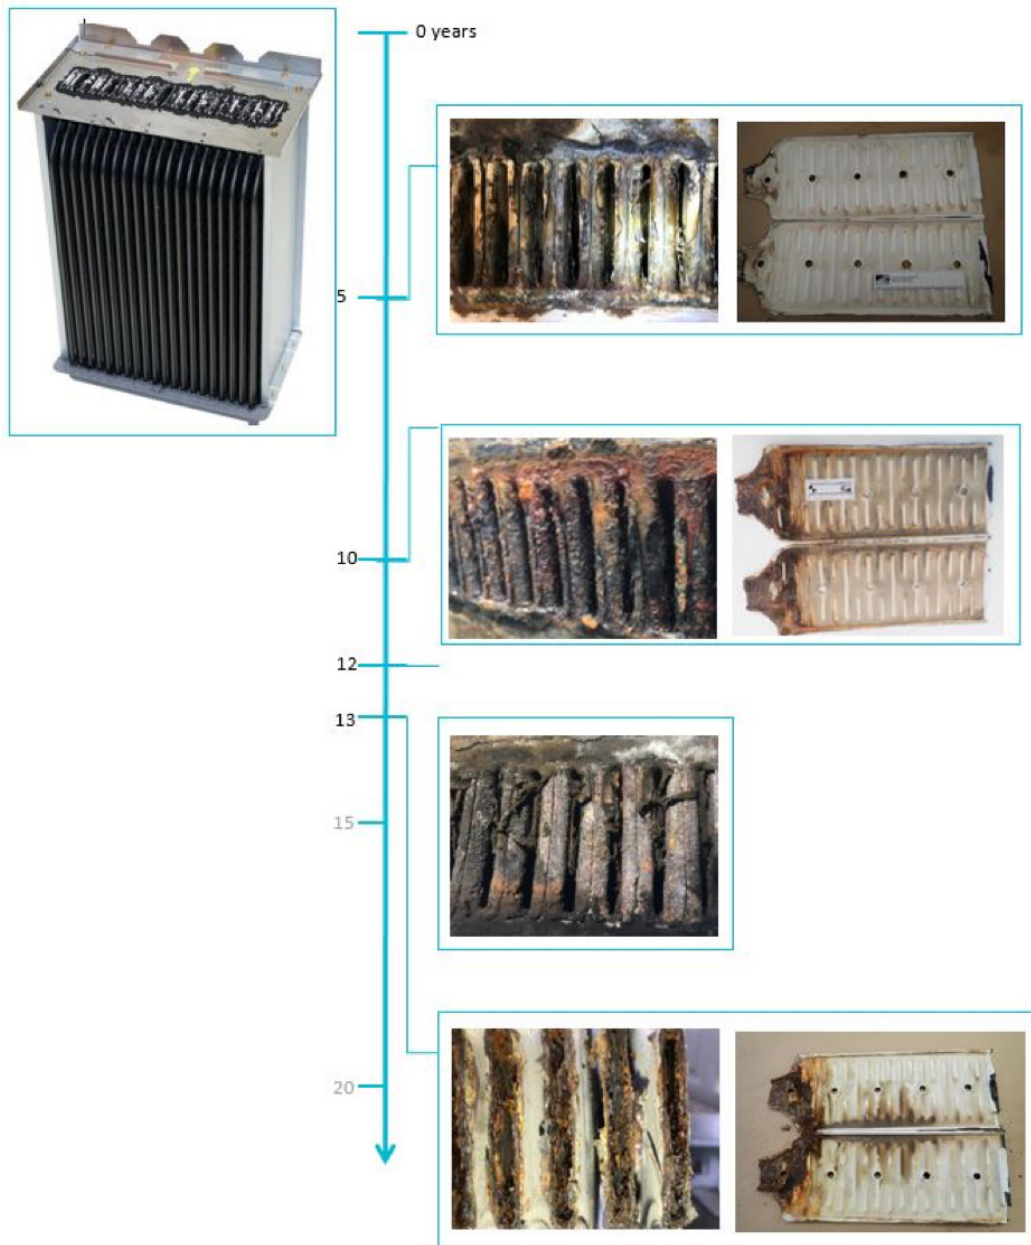
Photographic timeline of degradation:

These furnaces failed between 5 and 13 years of operation. All of the furnaces were found to be installed with the correct manufactures recommended slope to allow for proper drainage of the flue gas condensate. Photographs of the five furnaces investigated show the progression of degradation and corrosion over time in service. New secondary heat exchanger shows clean white polypropylene liners adhered at the inlet throats to the tubes with a black sealant around the mechanical joint between the tubes and the front plate (Image from new component from the parts supplier’s website).
